Manhole Inspection Summary

Manhole # S71E1_013MH

Insp Date: **2/13/08 12:55 PM**

Location Address: **6563 Saint Helena Ave.**

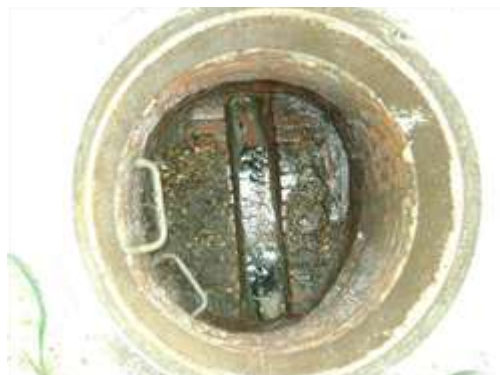
Top View

Comments **HEAVY SURCHARGE DEPOSITS ON BENCH.**

Condition: ☐ Sound ☐ Cracked ☐ Root Intrusion ☒ **Loose Brick** ☒ **Deteriorated**

Infiltration: ☐ None ☒ **Joint** ☐ Cracks ☒ **Mortar** ☐ Roots ☐ Wall

☒ **Evidence Of Surcharge** Depth: **1.5** (ft.) ☐ Active Surcharge Present

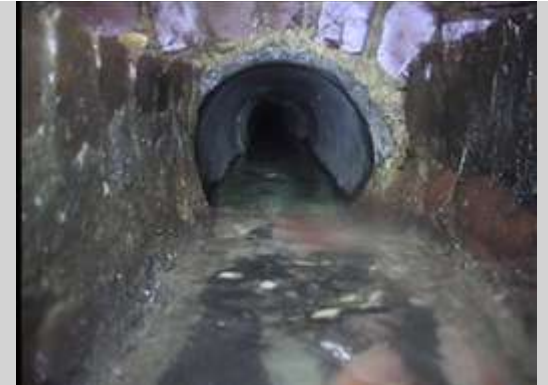
12 O'Clock Outflow

8 in. Circular Gravity Sewer
Pipe Out @ 12 O'Clock

Pipe Height: **8.4** (in.) Rod and Bar (Angled)
Pipe Material: **Clay** ☐ Pipe Lined
Invert Depth: **6.46** (ft.) Flow Characteristics: **Fast**
Deposits: ☐ None ☐ Mud ☐ Gravy ☒ **Debris** ☐ Grease
Silt Depth: **0.5** (in.) Deposits Extent: **Light**
Infiltration: **None** Pipe Seal Cond: **Sound**

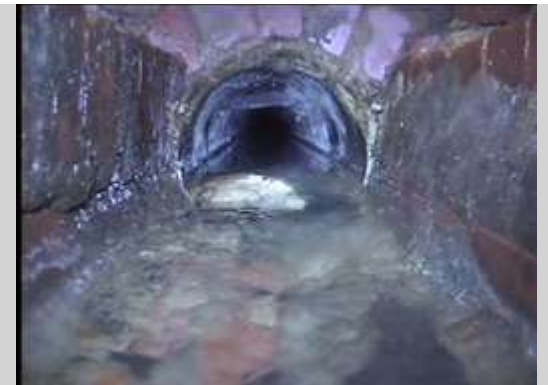
6 O'Clock Inflow

8 in. Circular Gravity Sewer
Pipe In @ 6 O'Clock

Pipe Height: **8.4** (in.) Rod and Bar (Angled)
Pipe Material: **Clay** ☐ Pipe Lined
Invert Depth: **6.42** (ft.) Flow Characteristics: **Fast**
Deposits: ☐ None ☐ Mud ☒ Gravy ☒ **Debris** ☐ Grease
Silt Depth: **1** (in.) Deposits Extent: **Medium**
Infiltration: **None** Pipe Seal Cond: **Sound**
